VGP Service Bulletin 2 – GamesCare Switch Units May 2025

This service bulletin describes modification details for the GamesCare suite of switches (Smart SCART, Automatic Component Switch and SCART Expansion).

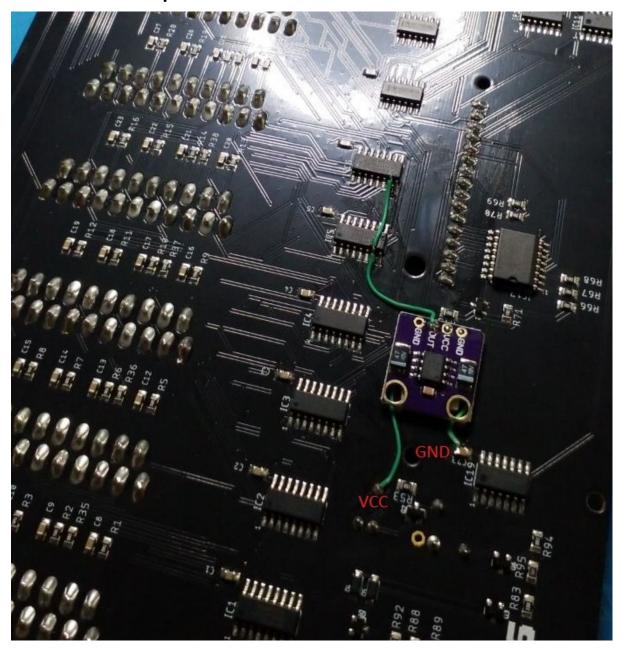
Examine the above image and locate IC's 5 and 6

Before soldering the new IC5 and IC6 components, lift pin 7 of both IC's, ensuring they are clear of the PCB pads.

When soldering the chips into position, do NOT solder pin 7 on both IC's. Ensure these 2 pins, one on each IC, are both kept clear of the PCB.

Using SMD rework tools, remove both IC5 and IC6, these will be replaced with uprated versions of the IC.

Fit the buck convertor in place using a suitable insulated fixing method and wire up as shown in the photo above using Kynar 28 awg hookup wire.

Ensure there are no shorts between VCC and GND before connecting power.

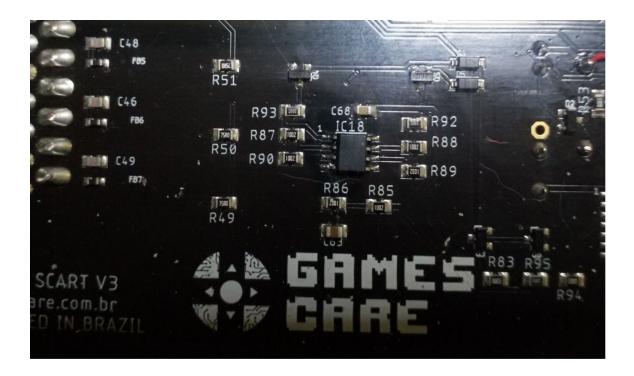
2. Op-Amp Replacement

The Smart SCART switch buffers its audio outputs through a unity gain operational amplifier. Some production units were manufactured with an LM358 op-amp but a TL972 is preferred as this is a higher performing device and will drastically improve the audio performance of the switch.

Locate and remove IC18 and fit the new op-amp into place.

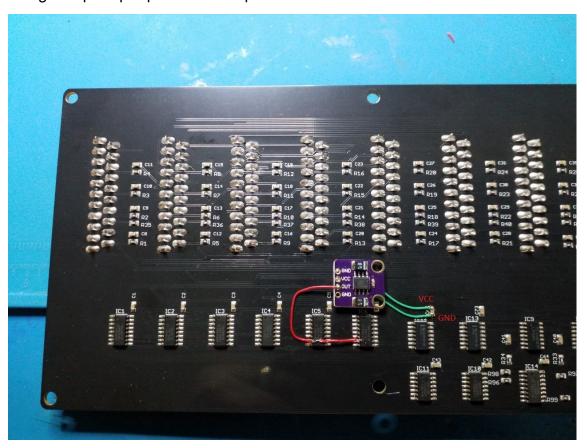
SCART Switch Expansion

The following image depicts the different component locations compared to the main switch unit.

The circuitry change rework is identical to the main switch unit, apart from there being no op-amp replacement required.

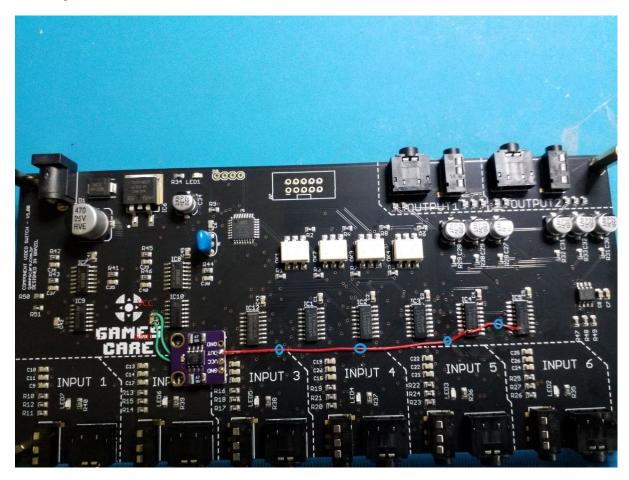
Component Switch

The procedure is largely the same as the SCART switch apart from:-

The modification is carried out on the top side of the board.

There is no op-amp to be replaced.

IC 4 and IC 5 are only to be reworked and not replaced.

Using suitable rework tools, pin 7 of IC4 and IC5 must be carefully lifted ensuring that they are clear of the PCB pads.

Once the wiring has been completed as shown above, it is highly recommended to use some Bostik Fix and Flash, or similar glue, to secure the wire to the points circled in blue in the above photo.
